**First South East European
Regional CIGRÉ Conference**

**Removing 3-core Oil-Filled Submarine
Power Cable
Dugi Rat –Postira from the Seabed**

110 kV Dugi Rat – Postira oil-filled cable

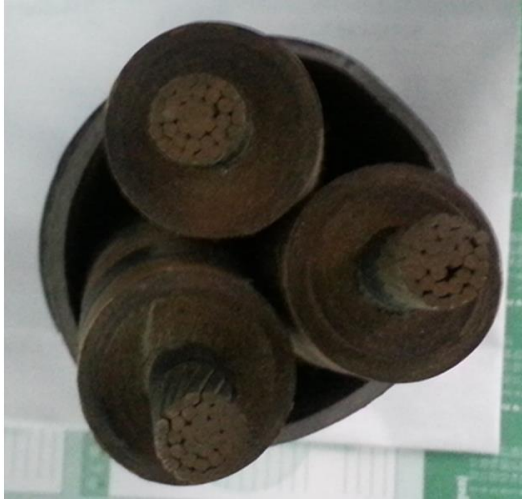
Fatal fault on 110 kV Dugi Rat – Postira oil-filled cable

- 3 September 1968 the cable was installed.
- At the beginning 800 m/hour → increased to 2000 m/hour.
- High altitude difference and long mainland section:
 - STOP JOINT ON THE CABLE LANDING POINT
- Postira:
 - cable was stressed probably more than allowed
 - sheath contracted into a trefoil formation
- During the initial stage of operation, by 1978 → 30 kV thereupon → 110 kV

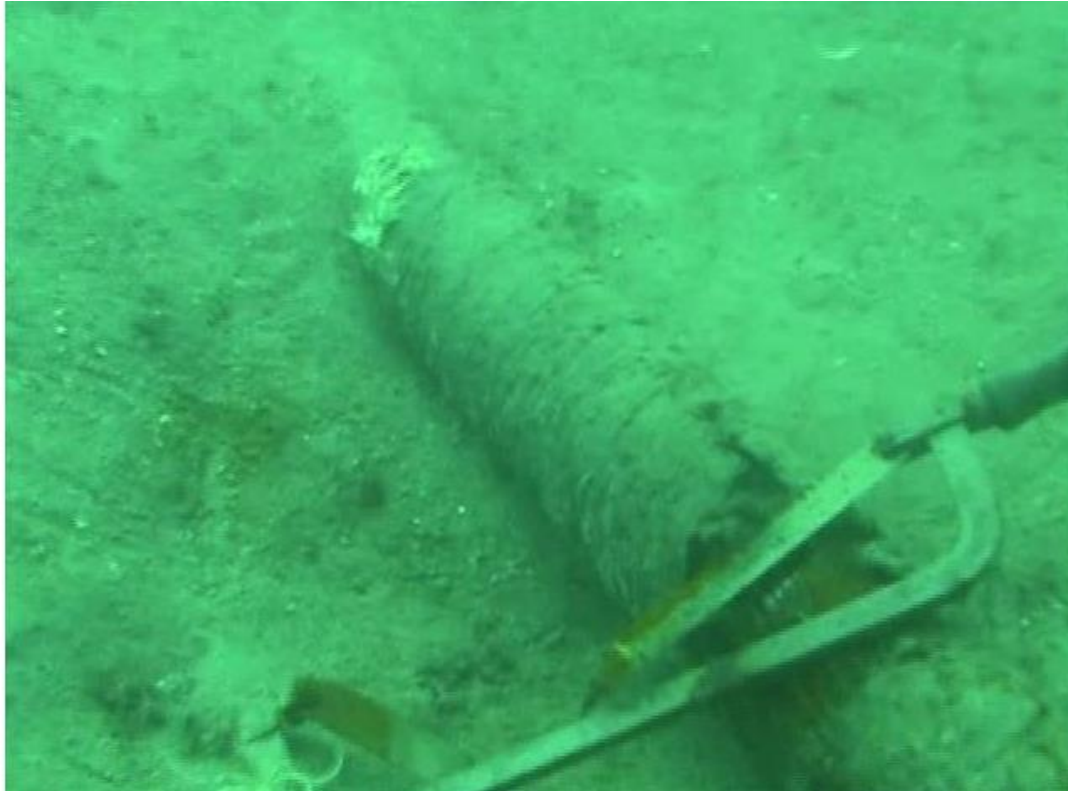
Attempt to repair the fault on 110 kV Dugi Rat – Postira oil-filled cable

- **UNKNOWN PERSON TRIED TO SAW UP THE CABLE**

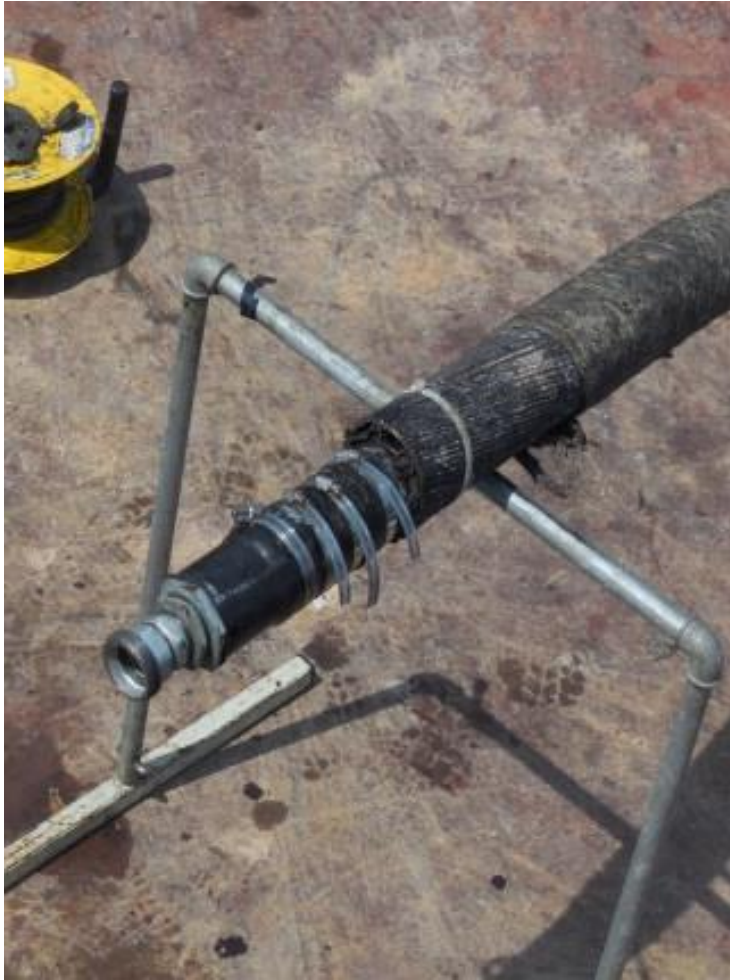
REPLACING 110 kV Dugi Rat – Postira OIL-FILLED CABLE - Process of cable oil removal

- **PRESSURE SIDE (DUGI RAT)** → pumping the seawater containing the chemicals (agent for decreasing the entire length of the cable)
- **SUCTION SIDE (BRAČ)** → cable content was collected in a vacuum tank by means of a compliant adapter
- On the pressure side, there were tanks with a mixture of seawater and degreaser, which was pumped into the cable
- On both sides → measurement and recording of the liquid media
- The liquid from the cable collected in the vacuum and additional tanks → transported to the waste management facility
